Manhole Inspection Summary

Manhole # S35II_035MH

Insp Date: **3/13/07 1:57 PM**

Location Address: **1600 CALVERT ST**

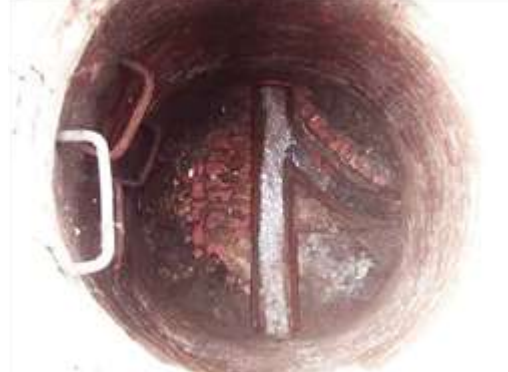
Top View

Corroded steps. Evidence of surcharge - Bench debris.

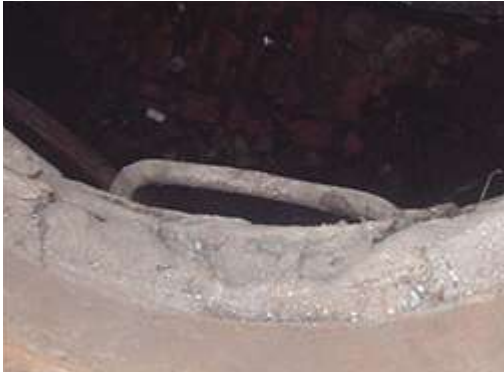
Defect

Frame leaks. Frame offset. Adjustment infiltration.

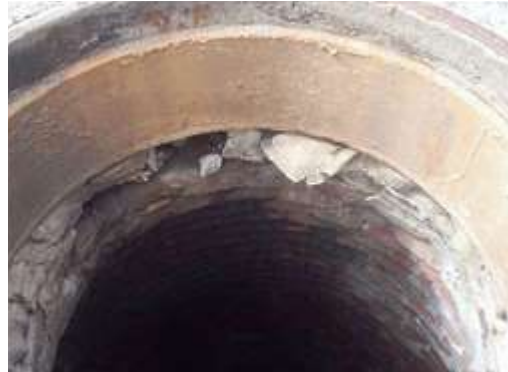
Defect

Frame leaks. Adjustment deterioration, loose brick, and infiltration. Corbel and Barrel infiltration.

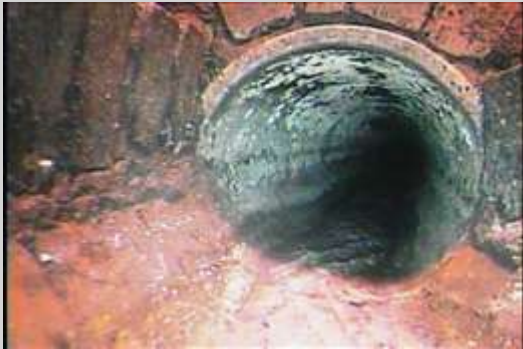
8 in. Circular Gravity Sewer Pipe Out @ 12 O'Clock

Infiltration: **Evidence** Pipe Seal Cond: **Unknown**

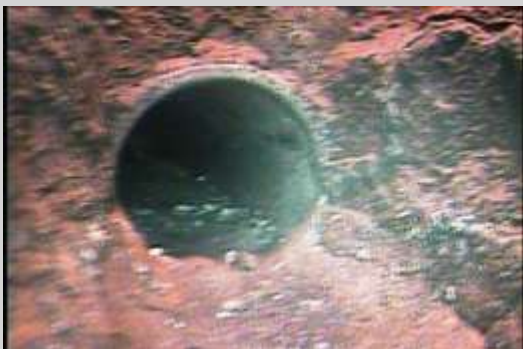
8 in. Circular Gravity Sewer Pipe In @ 3 O'Clock

Deposits: ☐ None ☒ **Mud** ☐ Sludge ☒ **Debris** ☐ Grease

Silt Depth: **1** (in.) Deposits Extent: **Light**
